WA-I-518 Frame House
Mid-20th century
Hagerstown Vicinity

## Maryland Historical Trust State Historic Sites Inventory Form

Survey No. WA-I-498 5/8

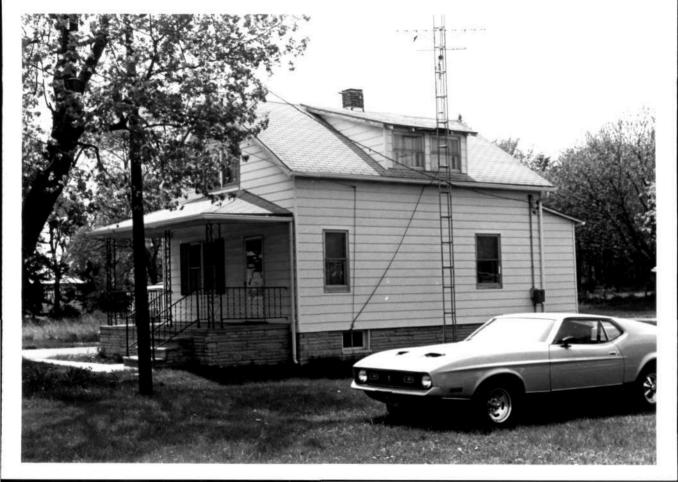
- l. Frame House WA-I-498-5/8
- 2. Washington County, Maryland
- 3. Joe Getty
- 4. May 1983
- 5. Maryland Hist. Trust, Annapolis, Md.
- 6. West Elevation; camera facing east
- 7. 1/1
